BUILDING A GROUND-LEVEL AZ/EL MOUNT: Volume VII

July 23, 2023

Joe Martin, K5SO

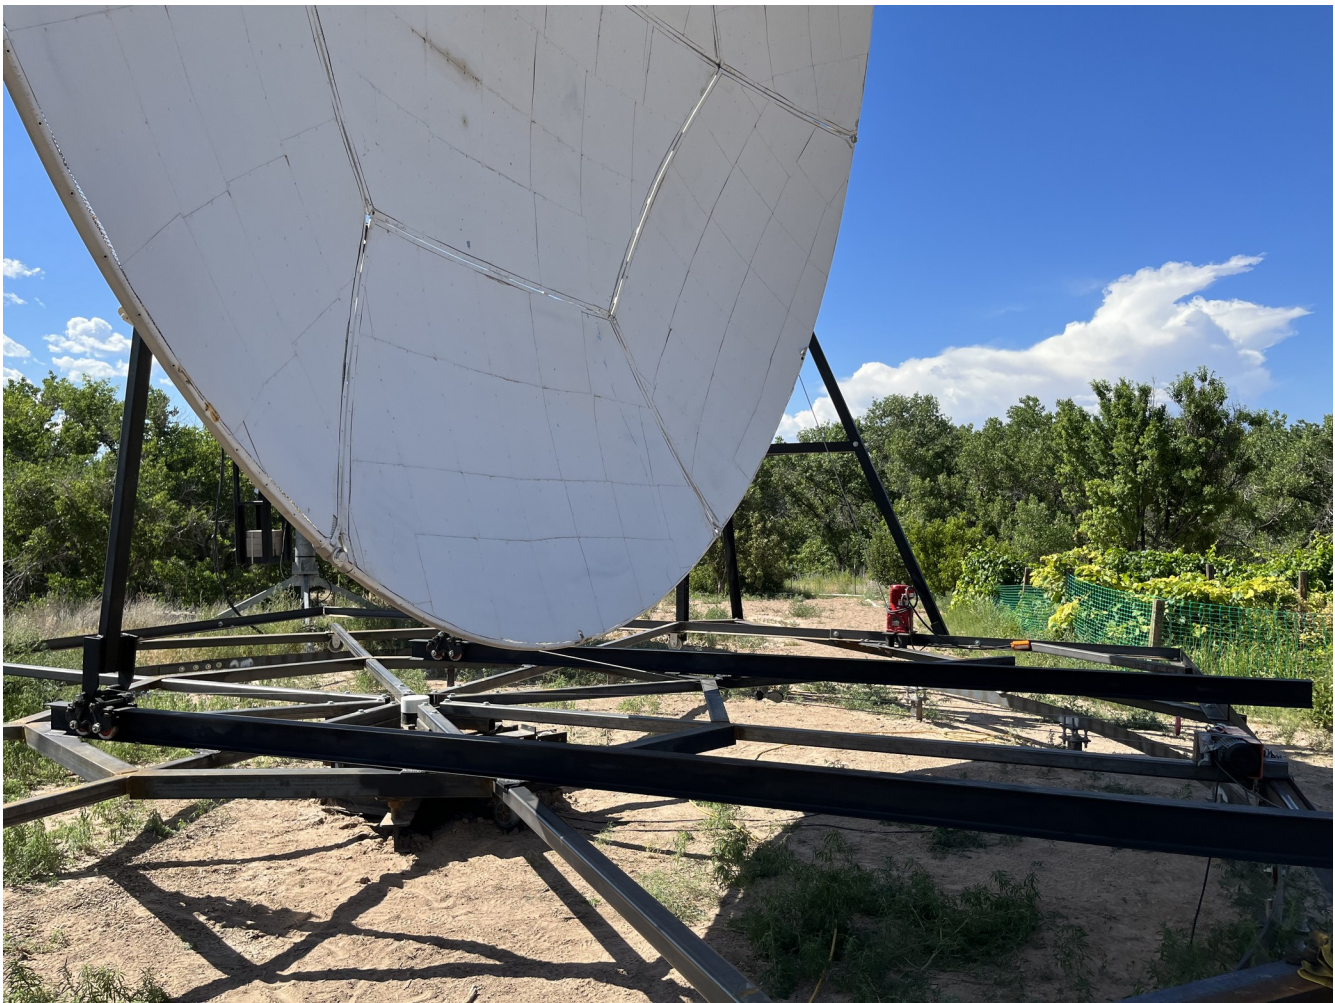
This experiment is the second time we have accessed negative angles in maintenance mode of such a magnitude that the horizontal trolleys traveled off the I-beams. During the first time, the I-beams were not welded onto the AZ mount, whereas this time the I-beams have been welded to the mount. As it happened, re-establishing the trolleys onto the I-beams was easier the first than this time because this time (i.e., with the I-beams welded to the AZ mount) one of the beams is slightly out of alignment with its trolley on the return of the trolley which required that a crow bar be used to force the trolley onto the I-beam. Such an action was unnecessary the first time as the trolleys and I-beams aligned nicely. To remedy the current misalignment the I-beam welds for this I-beam will be cut, the I-beam moved slightly for better return trolley alignment, and re-welded.

Figure 3. Configuration after the trolleys have been re-established onto the I-beams (23JUL2023).

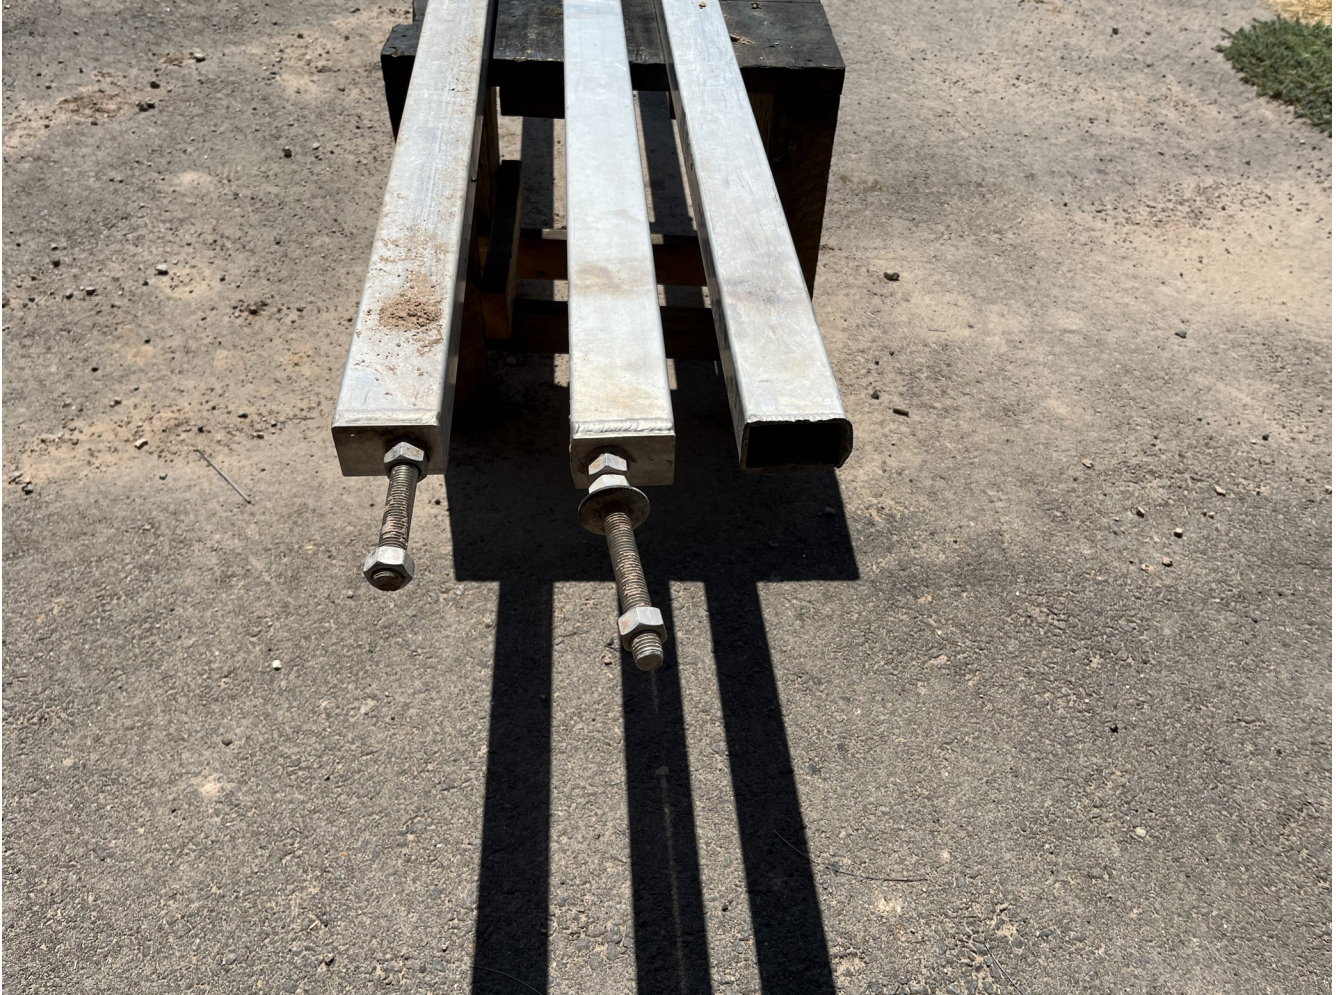
Figure 8. Circular ring ends of the feed support beams (25JUL2023).

The photograph above shows that two of the three aluminum support beams have suffered damage on the circular ring mounting ends. One beam is missing the attachment bolt and end flange entirely and one beam has the attachment bolt bent. Care will need to be exercised while straightening the bent bolt as the bolt is made of steel; which, of course, is much stronger than the aluminum mount into which it resides. There is a possibility of inadvertently damaging the aluminum flange while trying to straighten the steel bolt.

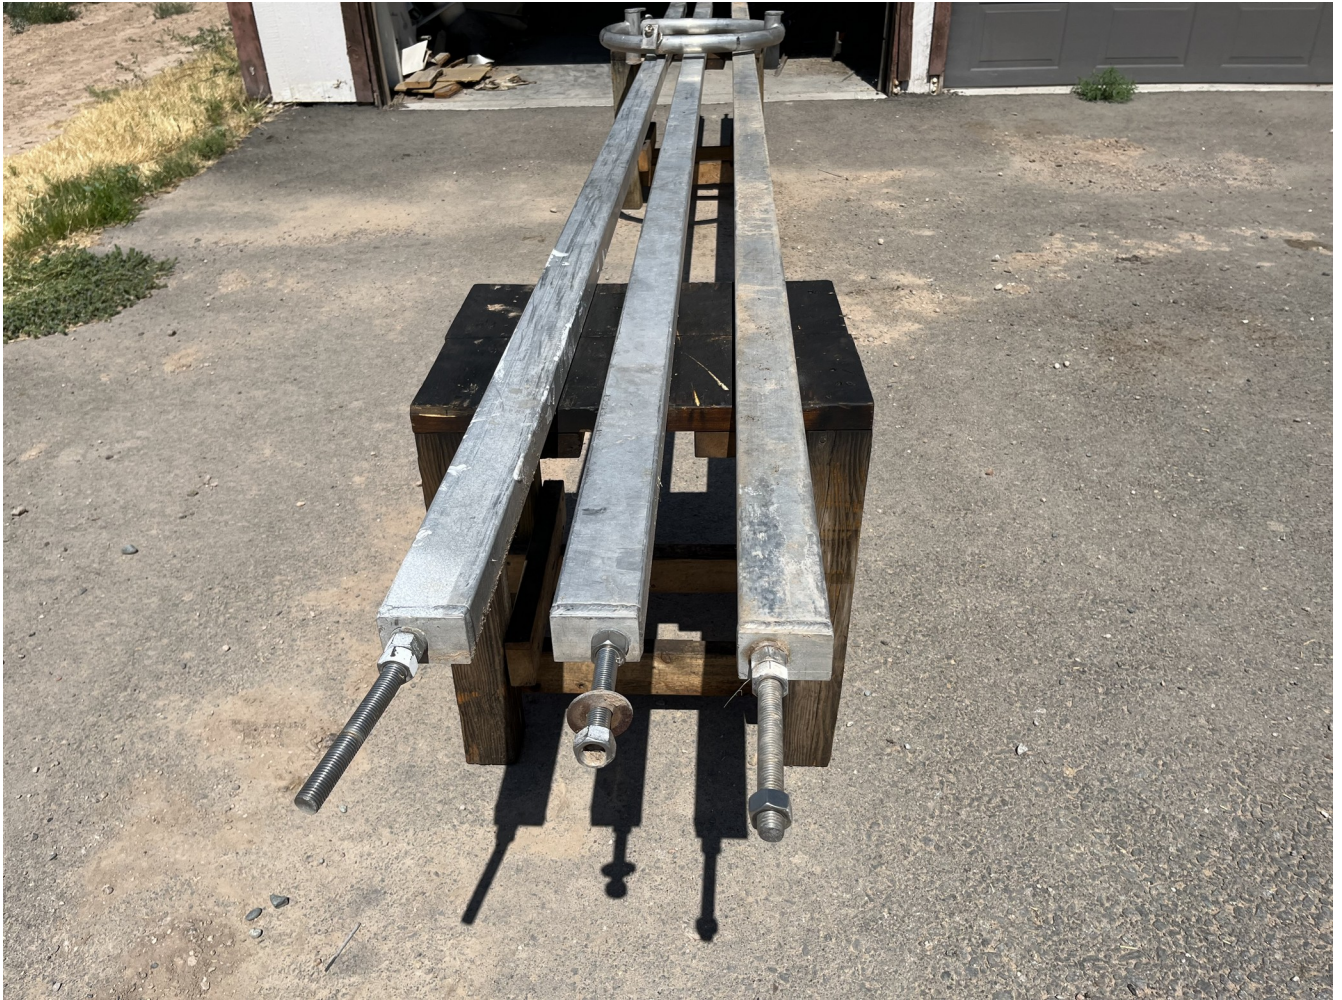
Figure 9. Dish rim ends of the feed horn support beams (25JUL2023).

The photograph above illustrates that two of the aluminum beam ends are usable without repair but one has a bent threaded bolt that must be carefully straightened.

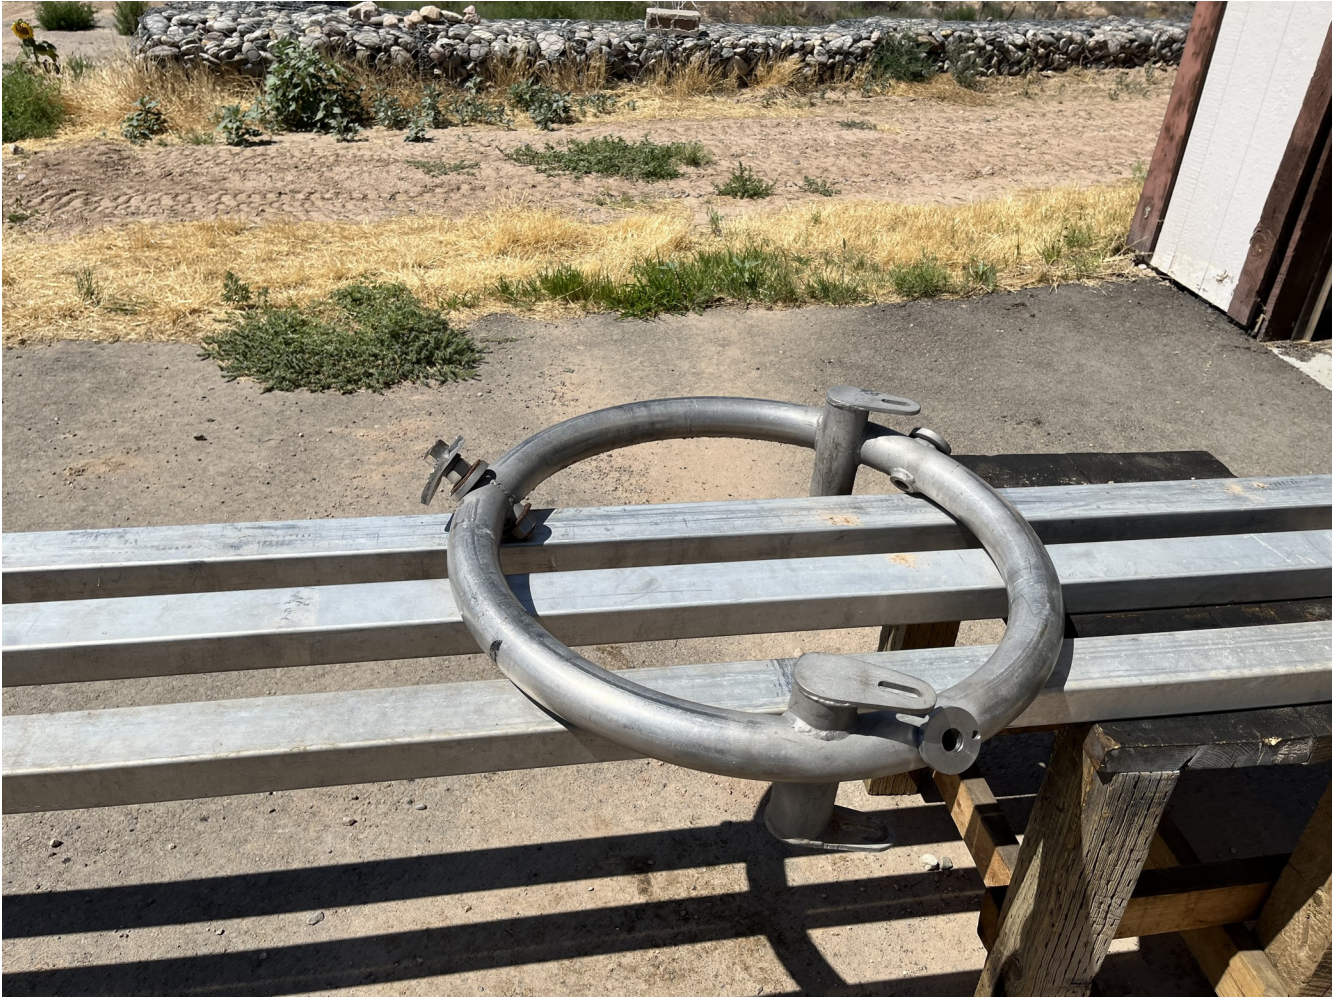
Figure 10. Feed horn mounting ring component of the feed horn support assembly (25JUL2023).

The feed horn mounting ring appears to be in good shape with no significant damage. The “missing” end piece of one of the support beams is seen still attached to the mounting ring, therefore fabrication of a new end piece for that beam may not be necessary. The end piece is shown at the upper left portion of the ring as viewed in the photograph. The aluminum flange piece is bent but can likely be straightforwardly straightened once it is removed from the ring. Remounting the flange piece into the beam may be challenging as aluminum welding is not my strong suite. An alternative option for this repair might be to bolt it into position on the beam instead of welding it. This possibility will be examined once the piece is removed from the ring and the condition of the beam end evaluated.

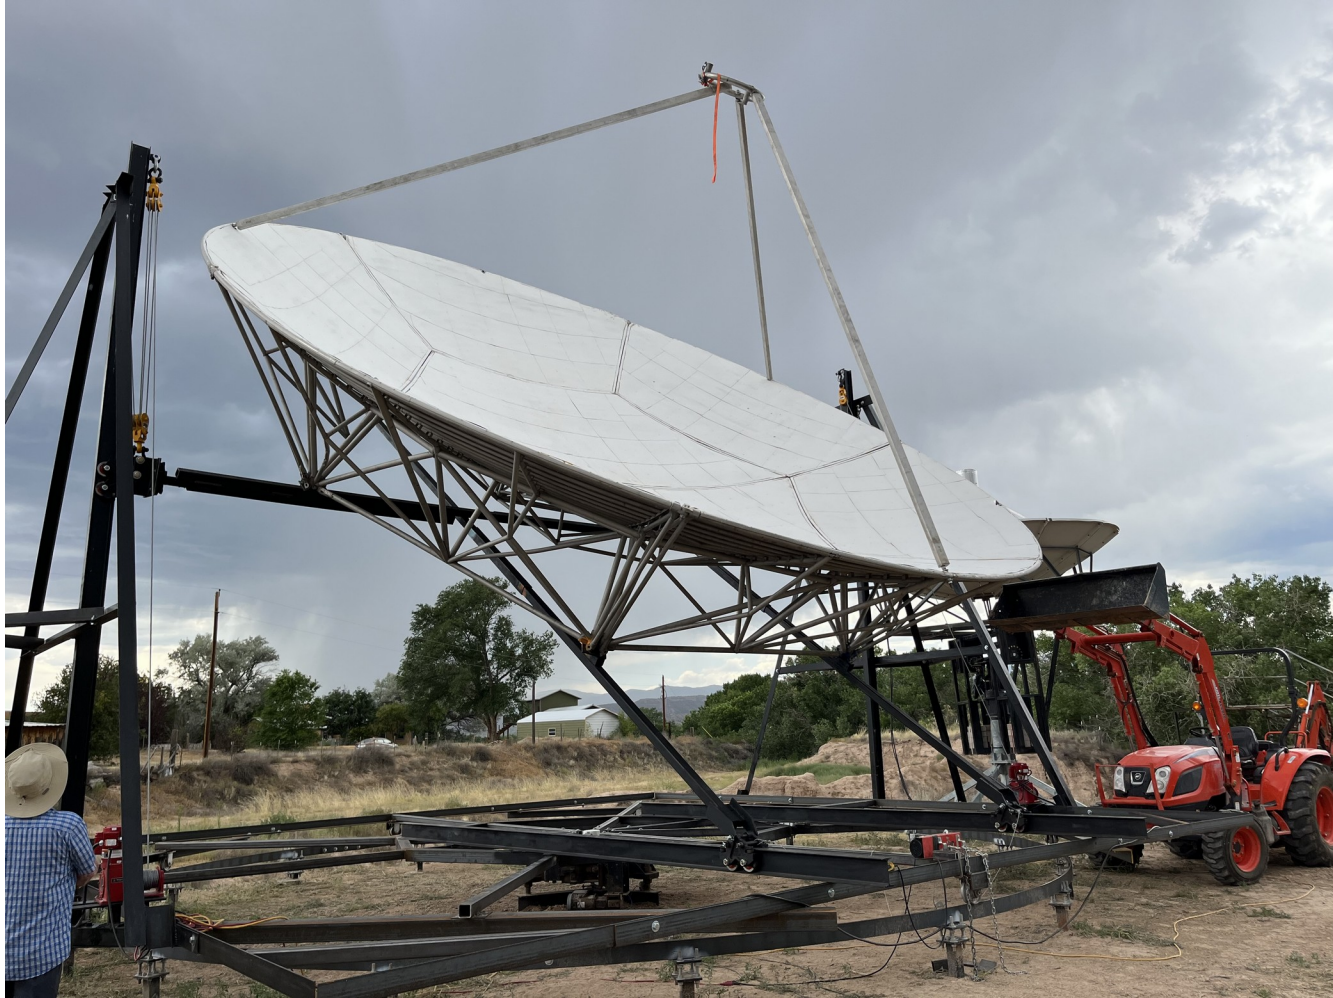
As luck would have it the newly repaired beam end broke at the repair during my installation attempt. Both ends of two of the support beams, the circular ring, and one end of the third support beam are bolted into place. The broken end (circular ring end) is temporarily held onto the circular ring using an adjustable strap until a repair can be performed on the beam end *in situ*.

Figure 14. Dish being lowered into bird bath position with the broken-end support temporarily strapped to the mounting ring (27JUL2023).

With rain closing in the work had to be temporarily suspended. The dish is being lowered into a safe orientation with the broken end beam temporarily strapped to the mount ring with the orange strap. The broken beam end will be repaired in place after the weather front moves through, with the dish pointing in a negative elevation angle to put the ring and broken end near or onto the rotating base platform to make access convenient. The tractor visible in the photograph wasn't used in the operation but was located nearby in case it was needed.

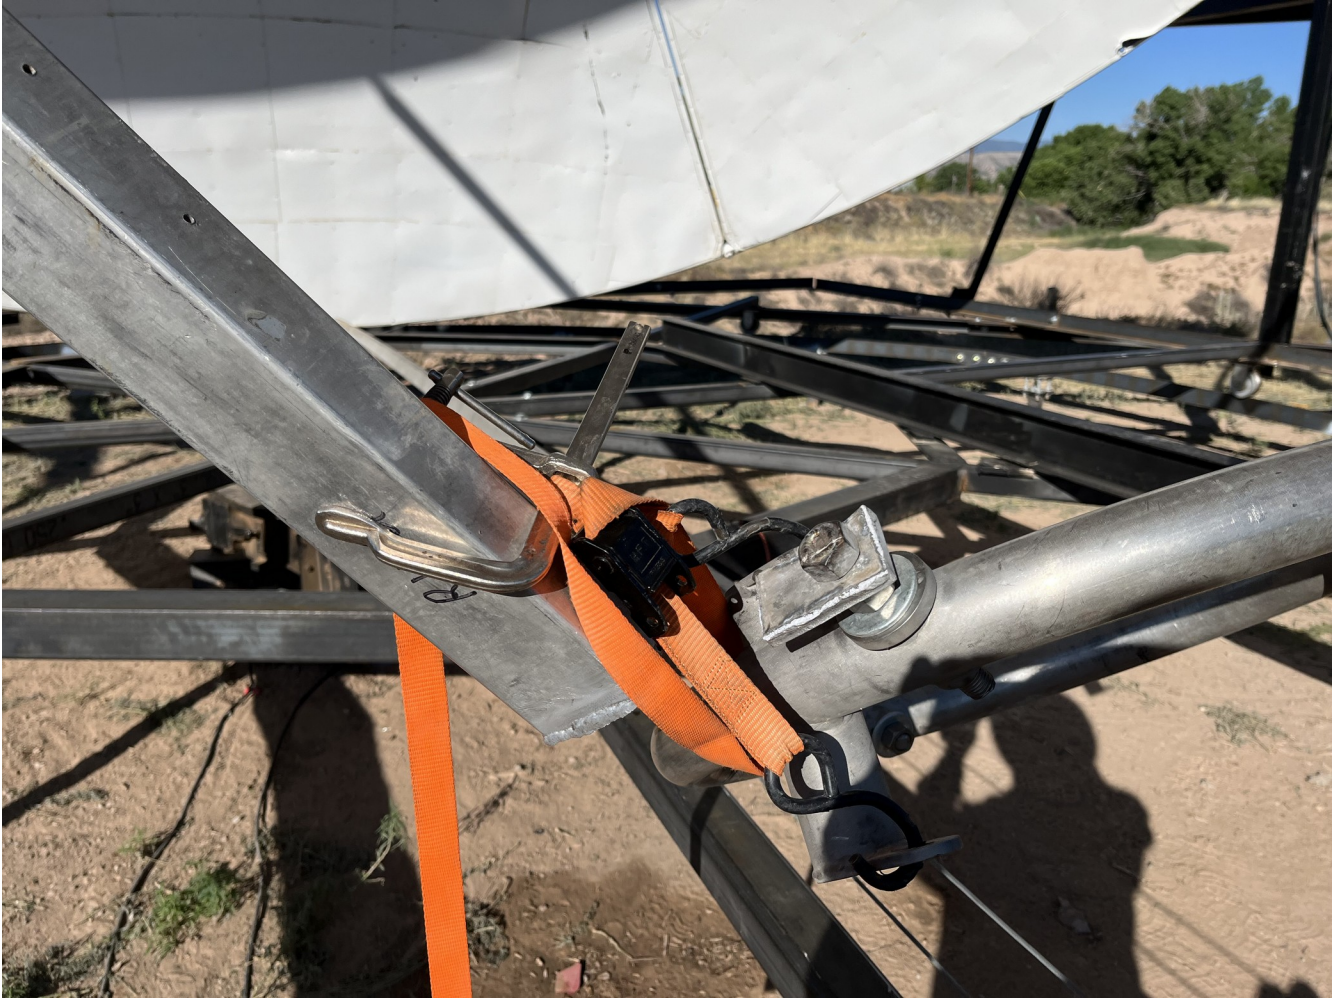
Figure 15. Broken beam end is strapped near the mating piece which is mounted onto the ring (28JUL2023).

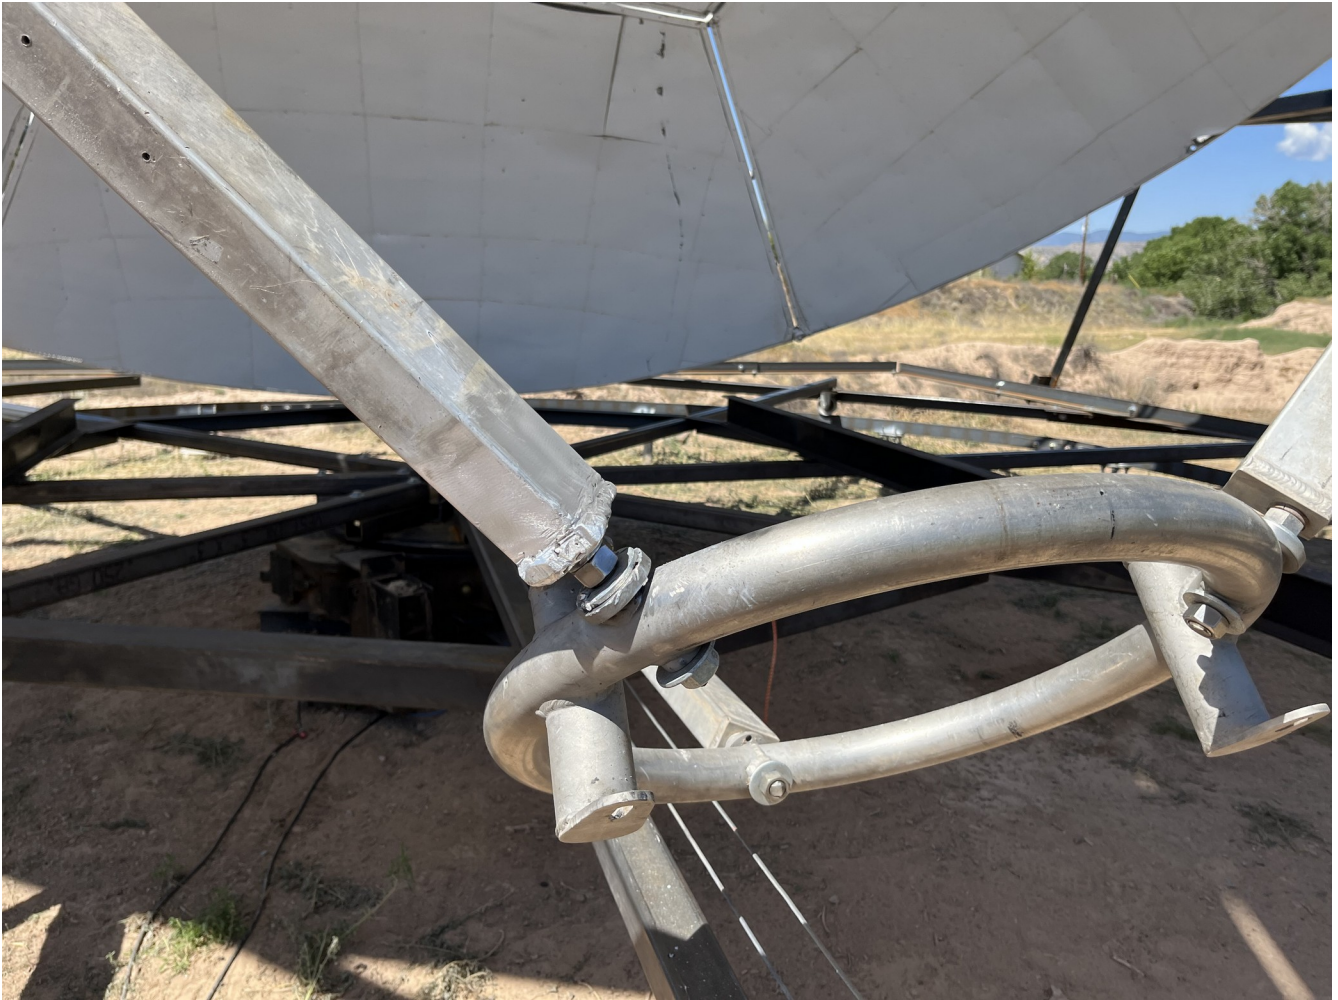
Admittedly, the welding job on this beam end is amateurish as my skill and experience welding aluminum is minimal at best. Fortunately, in use the weld won't experience the stress that the professional weld experienced during beam installation when the professional weld broke. It is hoped, even expected, that this weld is sufficiently strong that it will hold as needed for the life of the telescope.

Figure 18. View showing the completed aluminum weld of the support beam.
