BUILDING A GROUND-LEVEL AZ/EL MOUNT: Volume VII

July 23, 2023

Joe Martin, K5SO

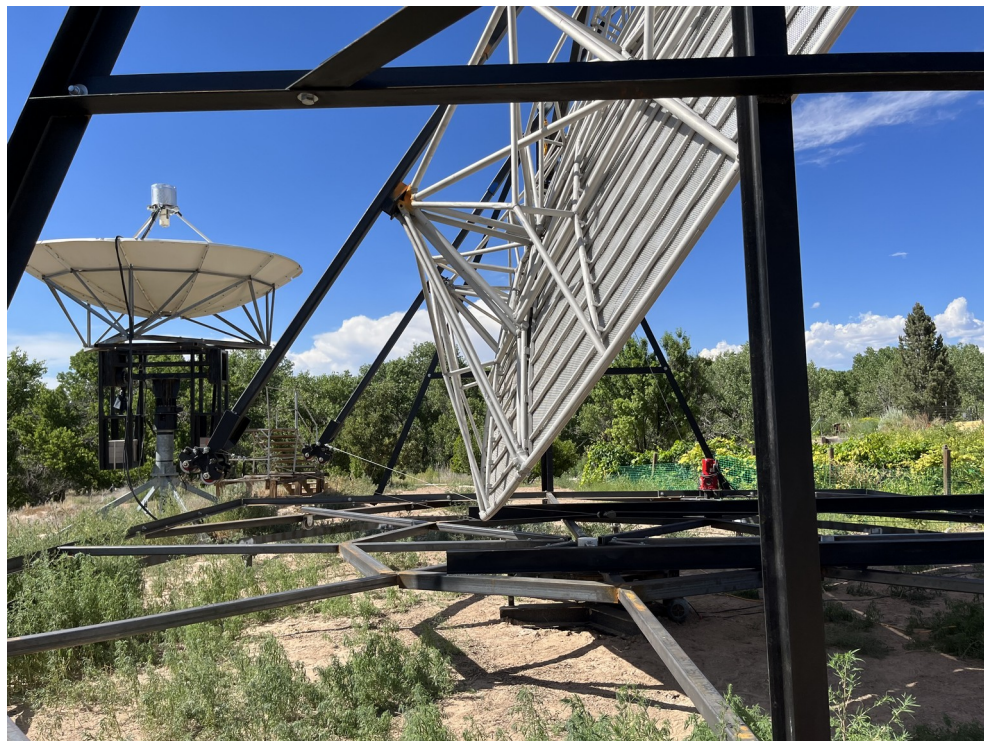
Figure 1. Dish shown at near -45 degrees elevation in maintenance mode (23JUL2023).

Note the steel cables attached to the two trolleys at the ends of the back frame beams. This amount of negative elevation angle is near the angle that will be needed to be able to access a feed horn from ground level. In any case, the dish can easily be lowered to larger negative angles simply by using the winch to release additional cable.

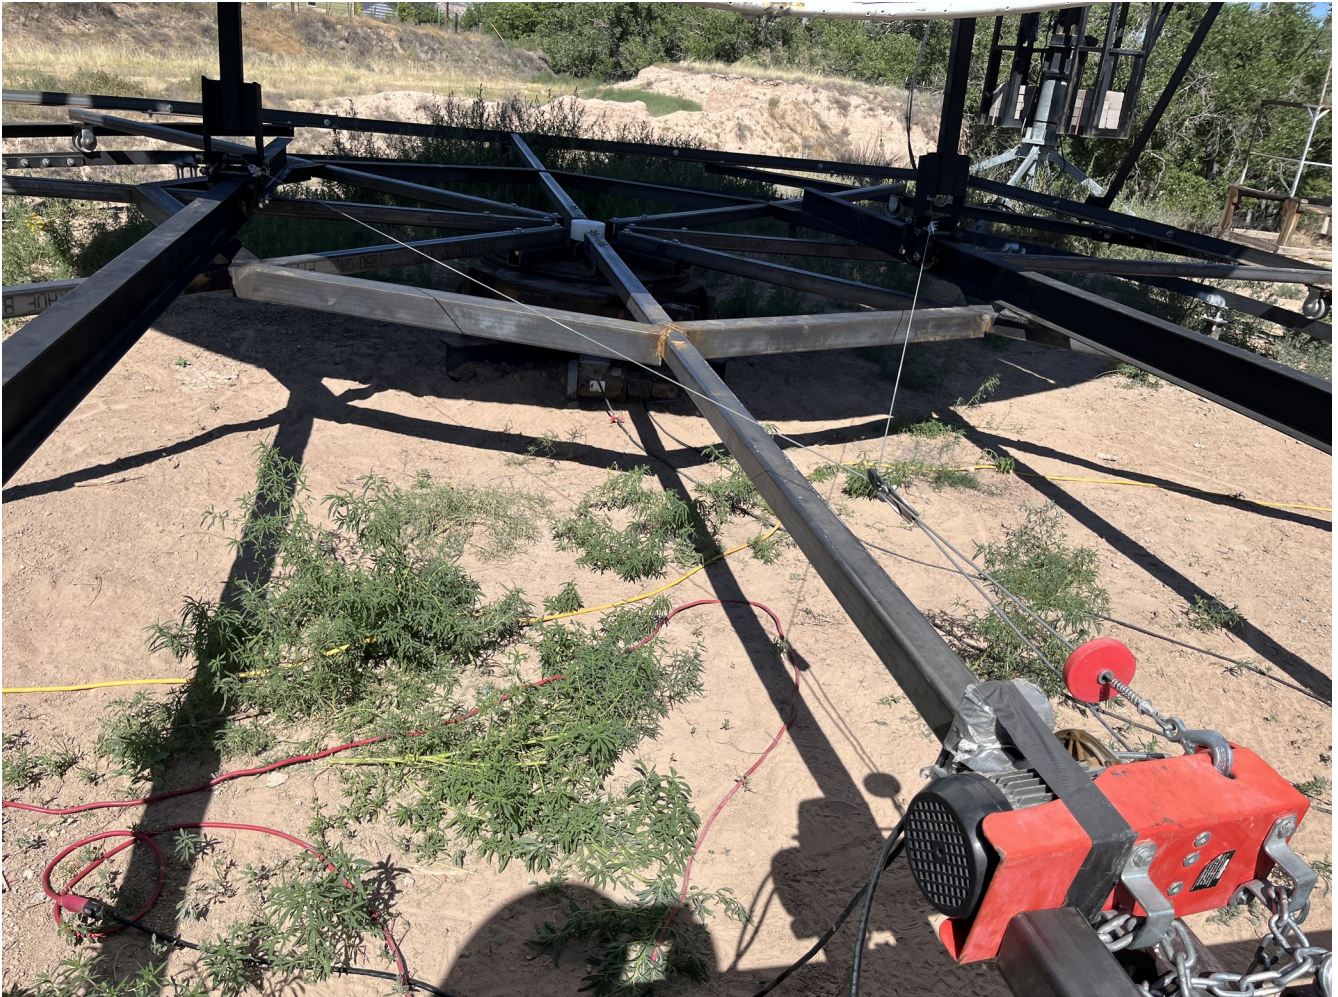
Figure 2. Winch connections for maintenance mode to access negative elevation angles safely (23JUL2023).

For this test an electric winch was temporarily chained to the side of the square perpendicular to the elevation axis of rotation. This configuration is temporary in the sense that it is used primarily to evaluate the concept for accessing negative elevation angles. A more permanent mounting arrangement will be implemented later.

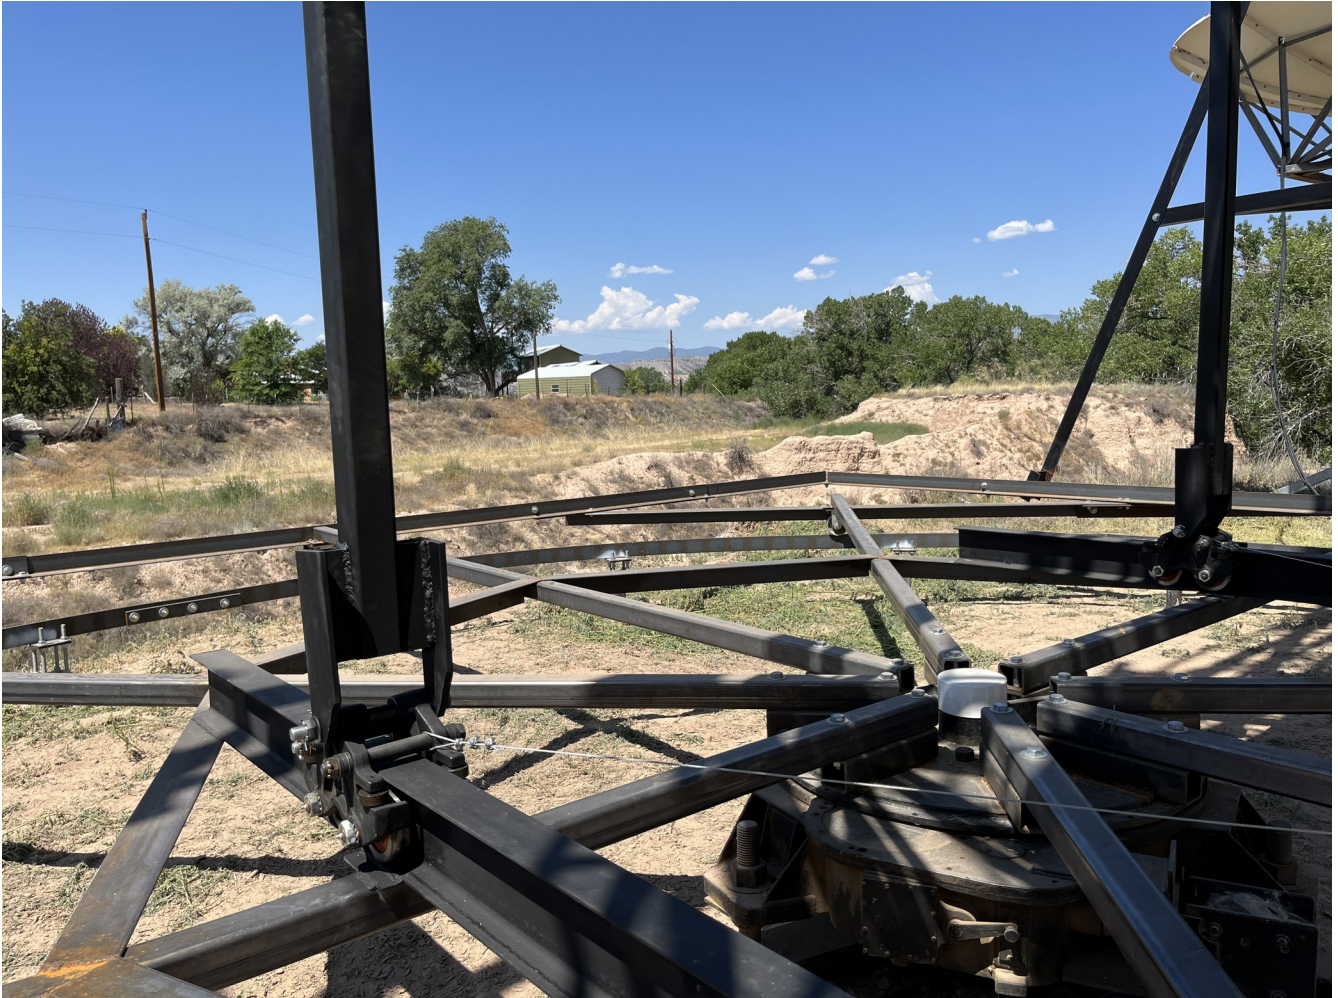
Figure 4. View showing how the maintenance mode cable connection is made to the horizontal trolleys (25JUL2023).

The front cross bolt position of the trolley was selected as the tie point to keep the back portion of the trolley level when the trolley is not established onto the I-beam. Trials using the top cross bolt proved unsatisfactory. In this current position the trolley nicely re-establishes itself onto the I-beam when it returns from large negative elevation angle positions without needing any intervention by the operator at the trolley position.

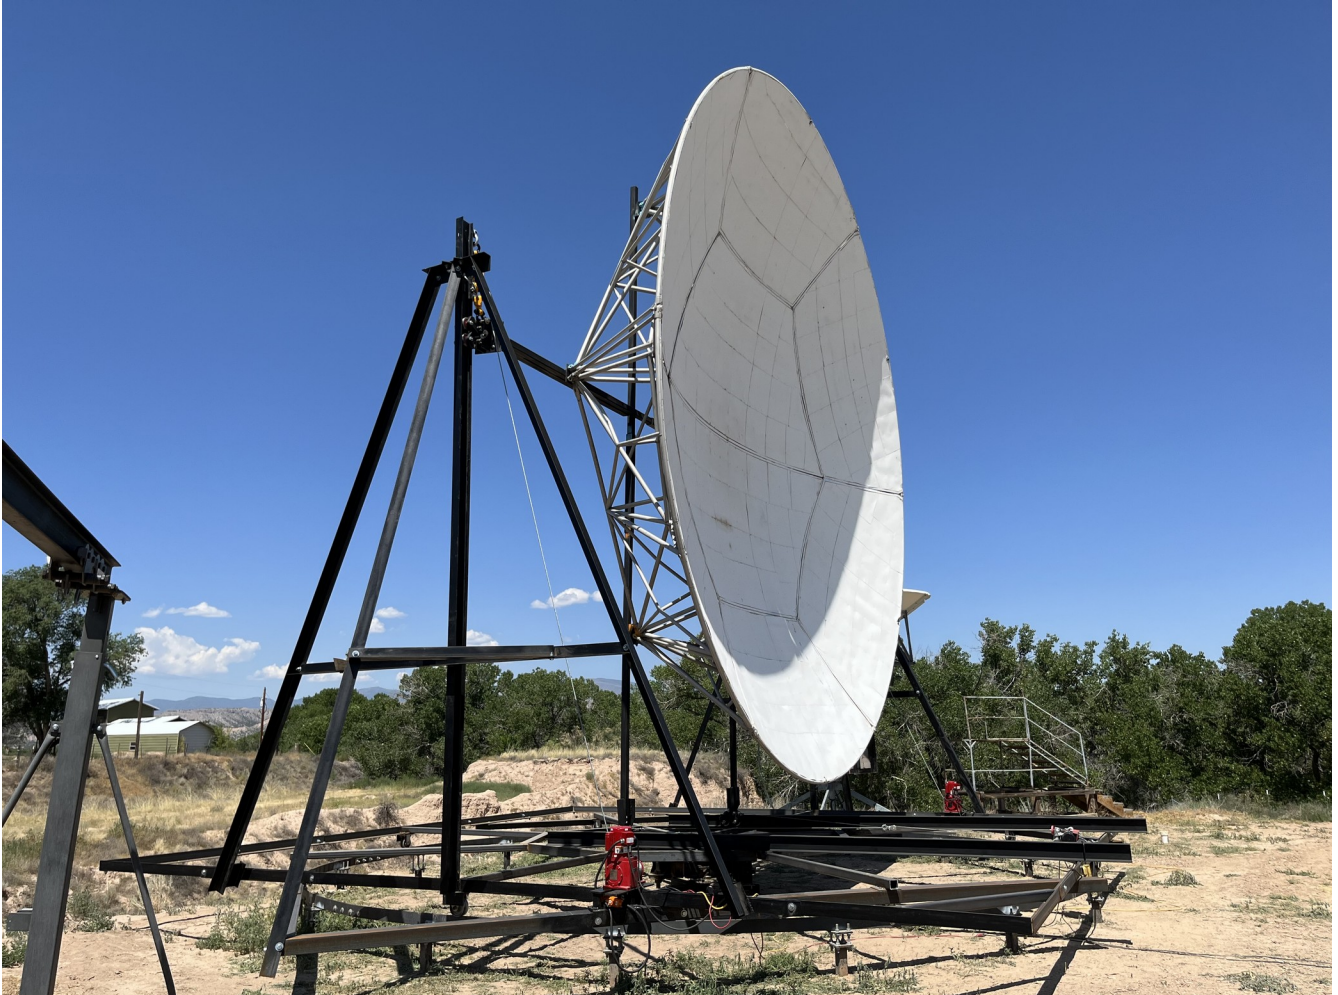
Figure 5. Dish shown at zero degrees elevation angle in maintenance mode (25JUL2023).

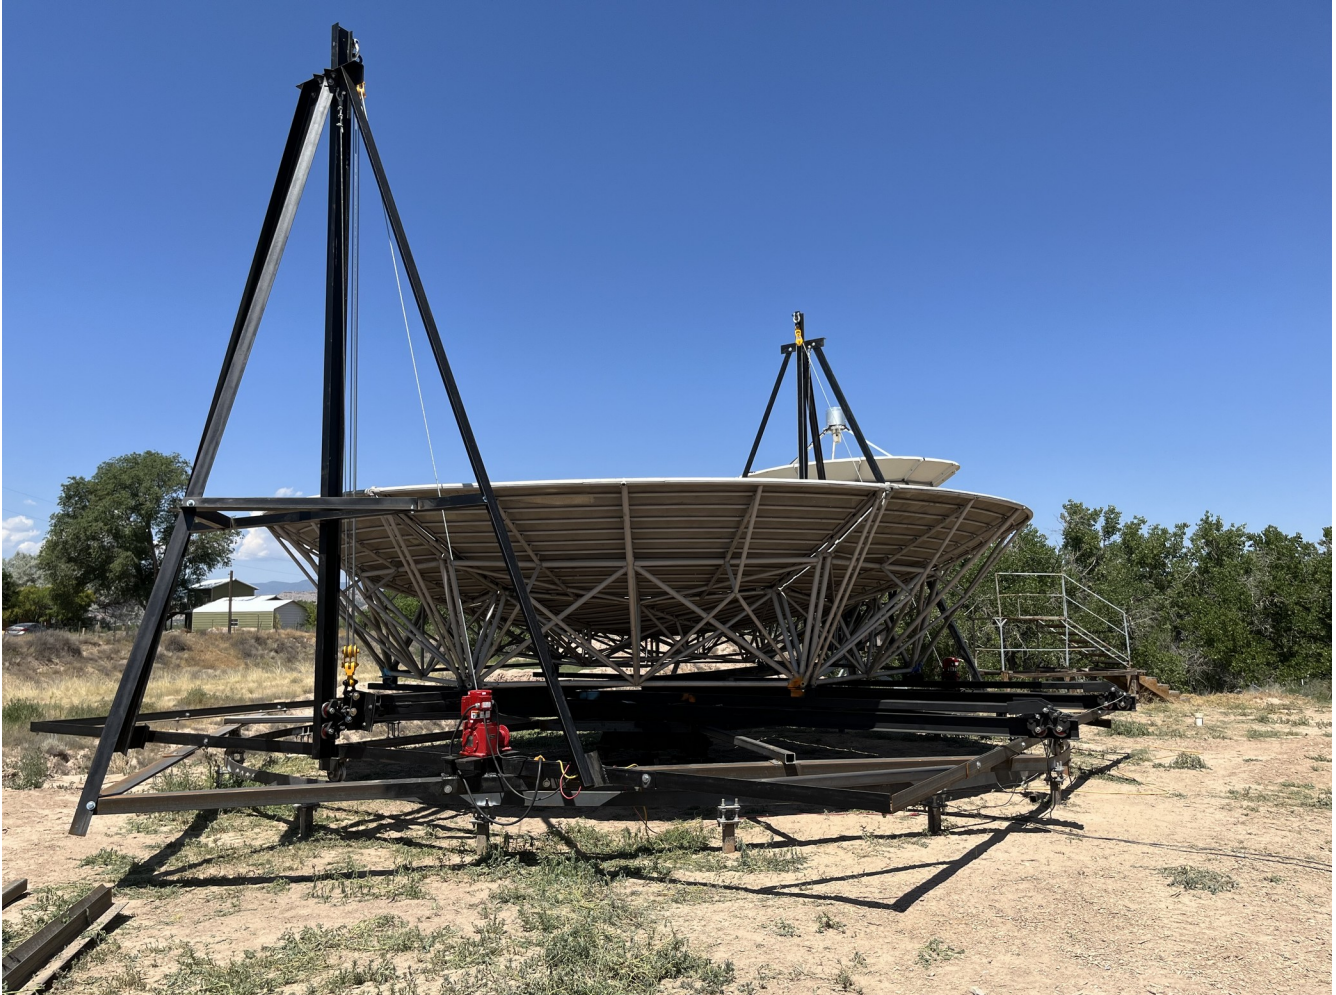
Figure 6. Dish shown in the storage position, normal operational mode (25JUL2023).

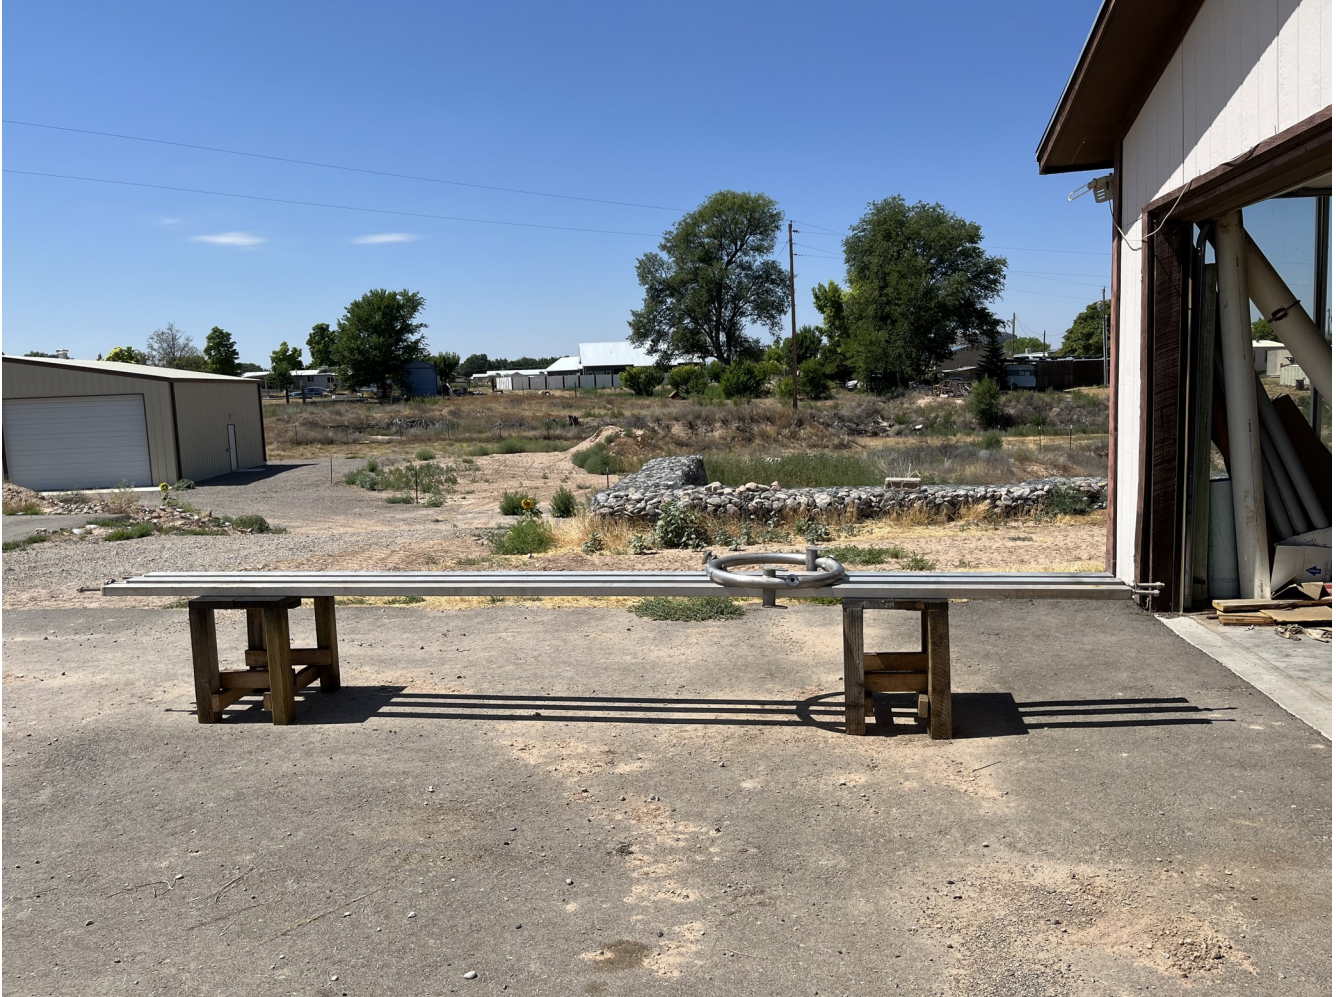
Figure 7. Feed horn support assembly components (25JUL2023).

The feed horn support assembly consists of 2"x4"x16' aluminum beams with steel threaded rods at both ends and a circular mounting ring into which the feed horn mounts. One end of each of the beams bolts onto the rim of the dish and the other end bolts onto the circular ring visible in the photograph.

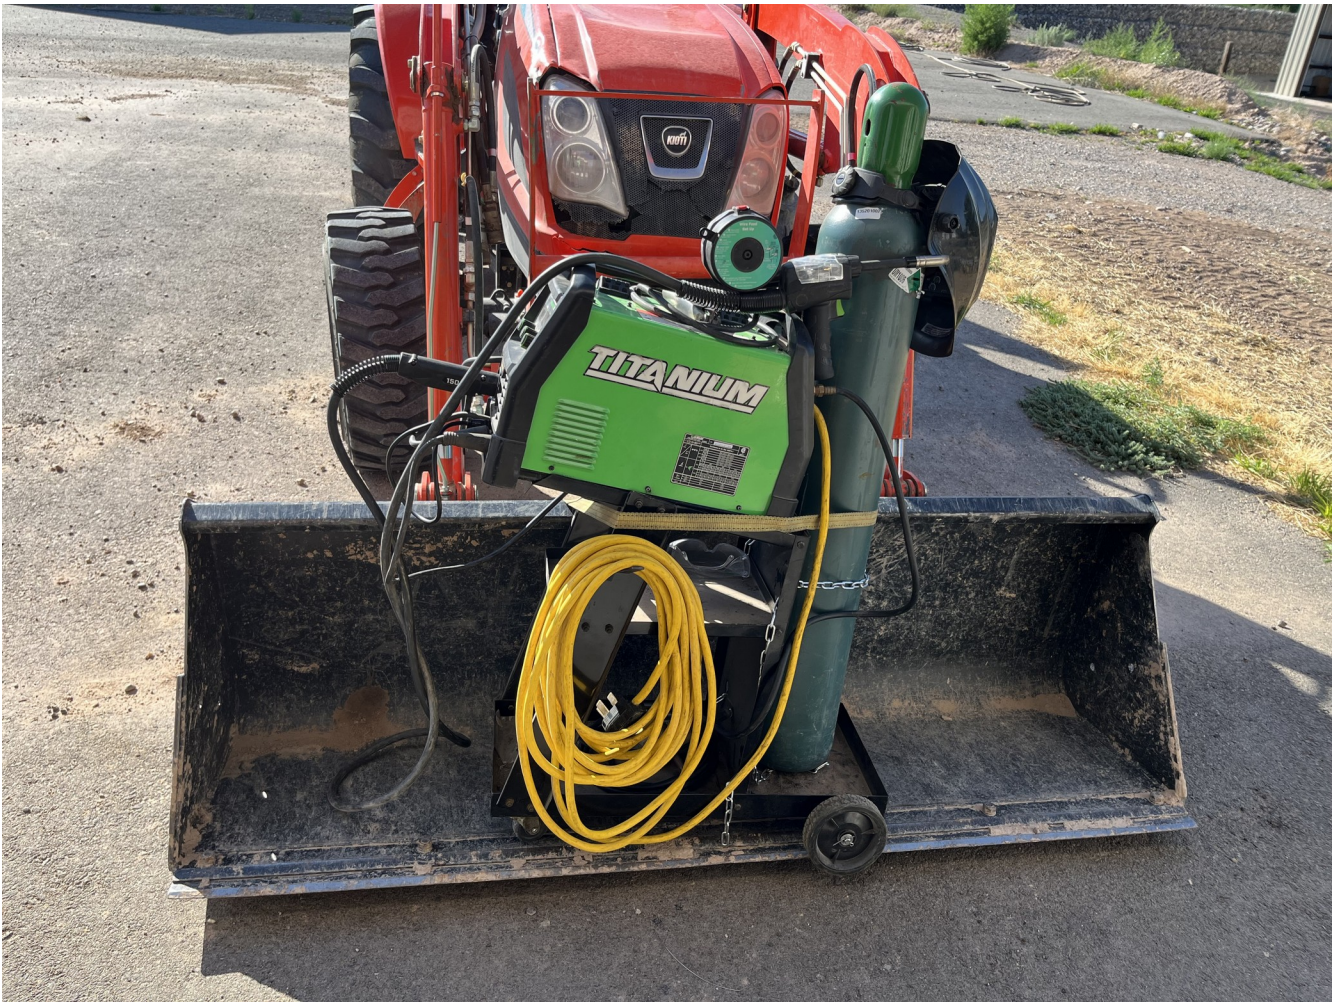
Figure 17. The MIG welder has been fitted with a spool gun and Argon gas bottle to weld aluminum (28JUL2023).

The numerous clamps and straps were necessary due to the angles present. The beam end and piece were welded in short sections in turn as each clamp was removed. The photograph below shows the tractor loaded with the MIG welder and Argon gas bottle to move the equipment to the dish to weld the aluminum beam *in situ*.

The welder cart was strapped onto the tractor bucket before moving the welder to the dish.

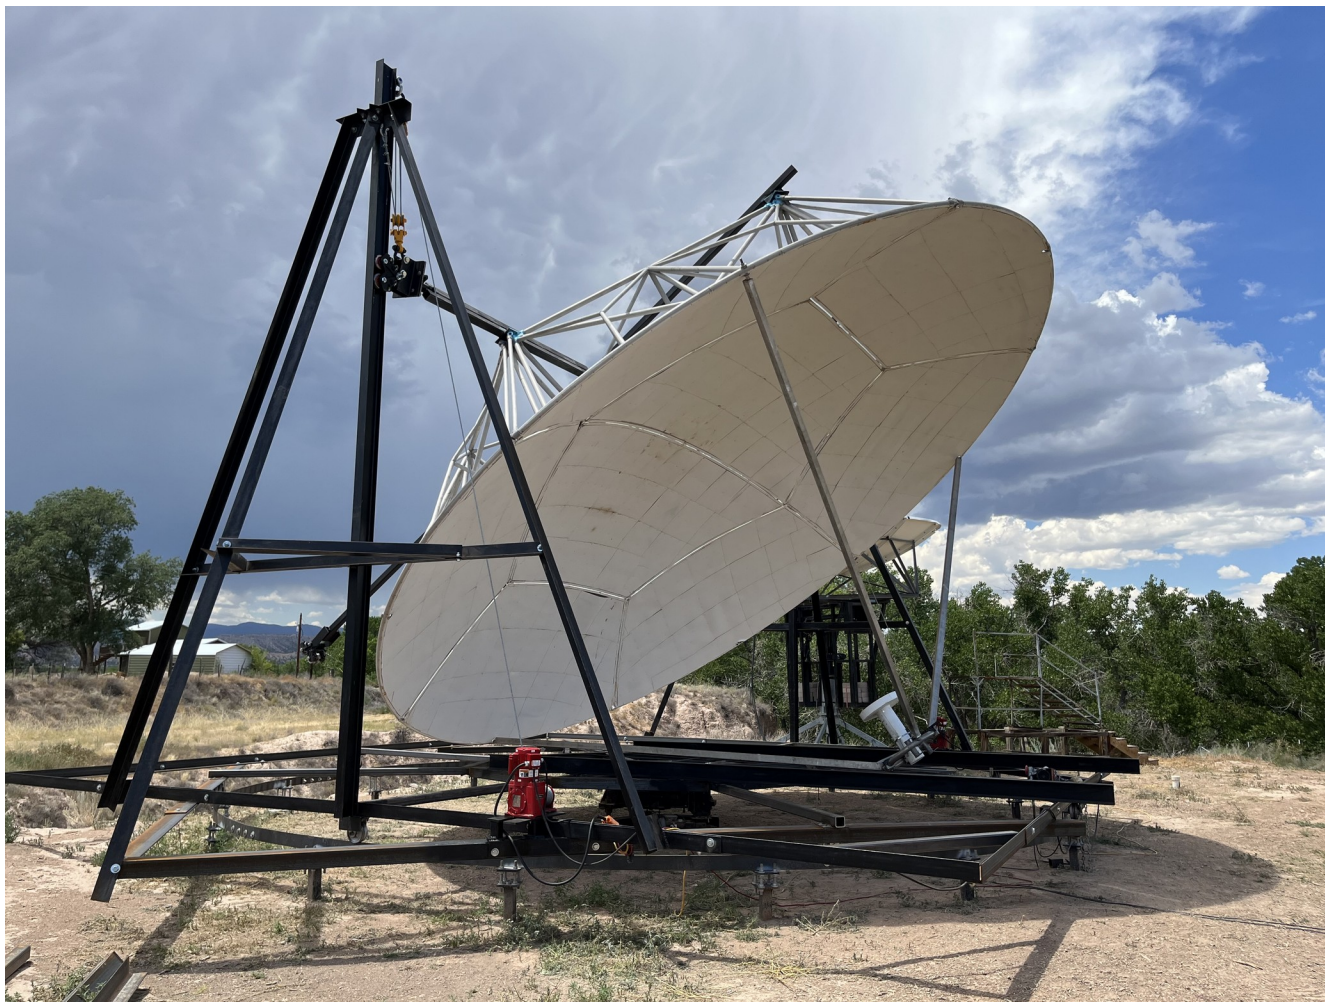
Figure 19. The dish has been tilted so that the feed horn may be straightforwardly installed from ground level (28JUL2023).

The L-band feed horn has been installed from ground level in maintenance mode with the end of the feed horn only 36" above ground level.

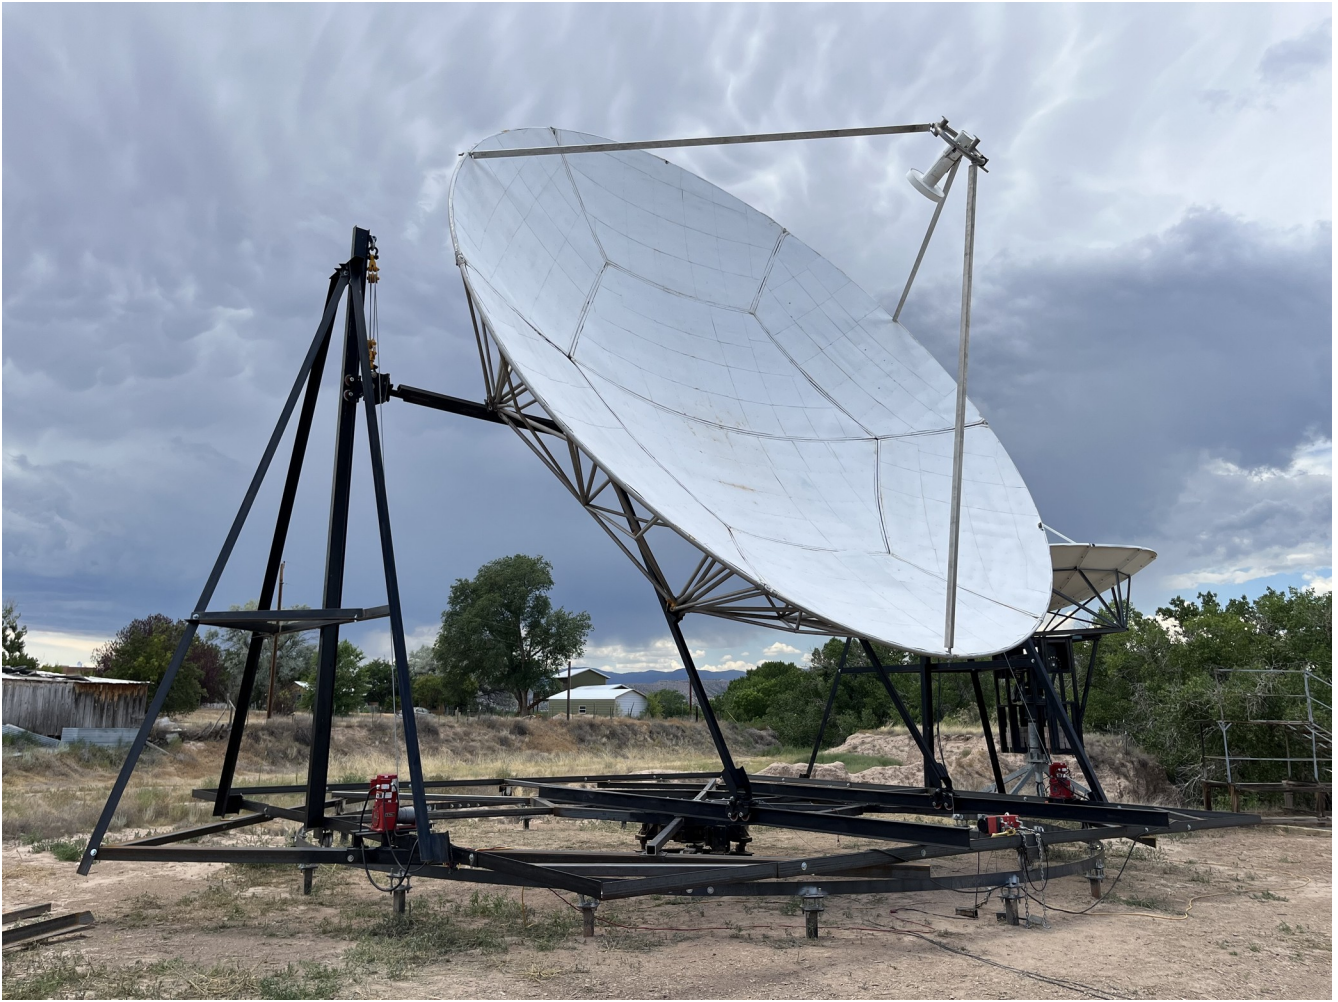
Figure 20. Dish is pointed skyward after installation of the feed horn (28JUL2023).

The dish is shown pointed skyward in normal operational mode.

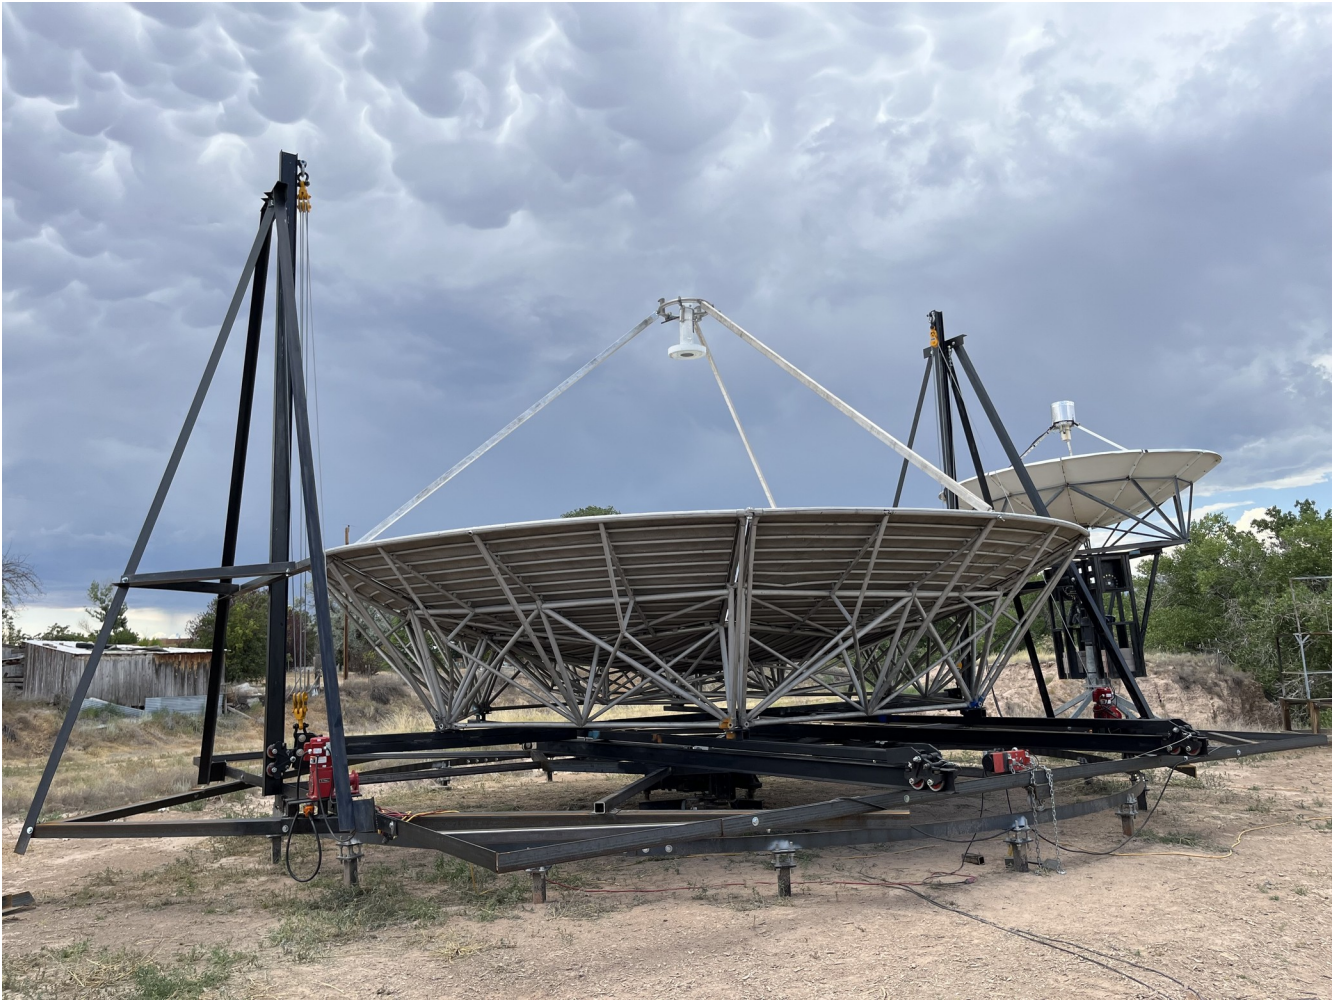
Figure 21. Dish is shown stored in bird bath position in normal operational mode (28JUL2023).

The configuration shown above is how the dish will be stored and how it will be oriented when foul weather occurs.
